DEPARTMENT OF TRANSPORTATION**DIVISION OF ENGINEERING SERVICES**

Contract #: 04-0120F4Cty: SF/ALA Rte: 80 PM: 13.2/13.9File #: 82.28**WELDING INSPECTION REPORT****Resident Engineer:**Siegenthaler, Peter**Address:** 333 Burma Road**City:** Oakland, CA 94607**Report No:** WIR-017429**Date Inspected:** 08-Oct-2010**Project Name:** SAS Superstructure**OSM Arrival Time:** 700**Prime Contractor:** American Bridge/Fluor Enterprises, a JV**OSM Departure Time:** 1530**Contractor:** Westmont Industries**Location:** Santa Fe Springs, CA.**CWI Name:** R. Rodriguez, R. Dominguez**CWI Present:** Yes No**Inspected CWI report:** Yes No N/A**Rod Oven in Use:** Yes No N/A**Electrode to specification:** Yes No N/A**Weld Procedures Followed:** Yes No N/A**Qualified Welders:** Yes No N/A**Verified Joint Fit-up:** Yes No N/A**Approved Drawings:** Yes No N/A**Approved WPS:** Yes No N/A**Delayed / Cancelled:** Yes No N/A**Bridge No:** 34-0006**Component:** Travelers**Summary of Items Observed:**

SAS-EB Traveler

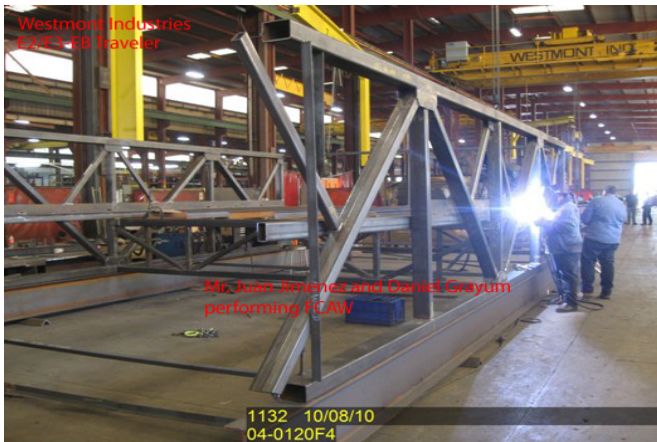
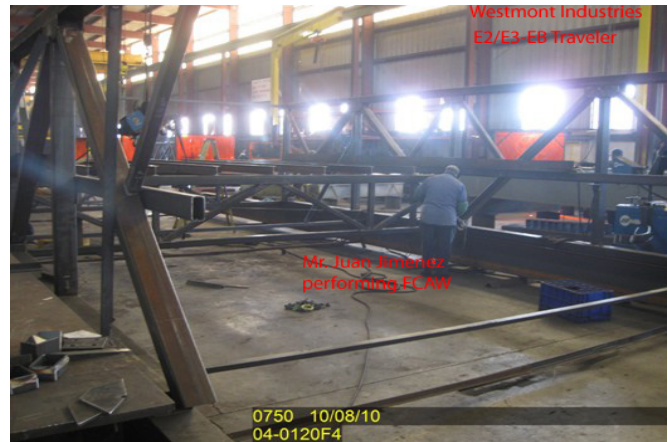
On this date, the QA Inspector observed Westmont Industries (WMI) production welders Daniel Grayum (WID # 3049) and Juan Jimenez (WID # 3059) continuing to perform Flux Core Arc Welding (FCAW) activities for the E2/E3-EB Traveler. The QA Inspector observed that the FCAW in various positions and the FCAW was being performed on the previously tack welded frame assemblies identified as A214, A216, A235 and B235. The QA Inspector observed that these welds are identified as fillet and flare groove and these frame assemblies are designated as assemblies for the fabrication of the Elevated Truss Section of the Traveler, per the approved Shop Drawings. The QA Inspector observed that the FCAW was being performed on Tube Steel and plate material and that the FCAW throughout the end of shift.

On this date, the QA Inspector observed Smith Emery QC Inspector, Ruben Dominguez, performing Visual Testing (VT) on previously completed Fillet and Flare Groove welds, for the Elevated Truss Section Assembly. The QA Inspector observed QC Inspector Dominguez marking up multiple areas of the completed welds, utilizing a soapstone marking device. After marking up the areas, Mr. Dominguez explained that multiple areas of weld undercut, under fill and weld spatter were present. QC Inspector Dominguez explained that these areas, which were marked, were unacceptable per AWS D1.1 2002. The QA Inspector then observed production welder Daniel Grayum, perform grinding activities on the above mentioned areas, utilizing a mechanical grinder. The QA Inspector observed that Mr. Grayum continued these activities throughout the end of the shift.
